LIRIS COMPRESSOR N°:1

Modifications to the cold head motor control board.

Roberto Martínez Rayón September 2018

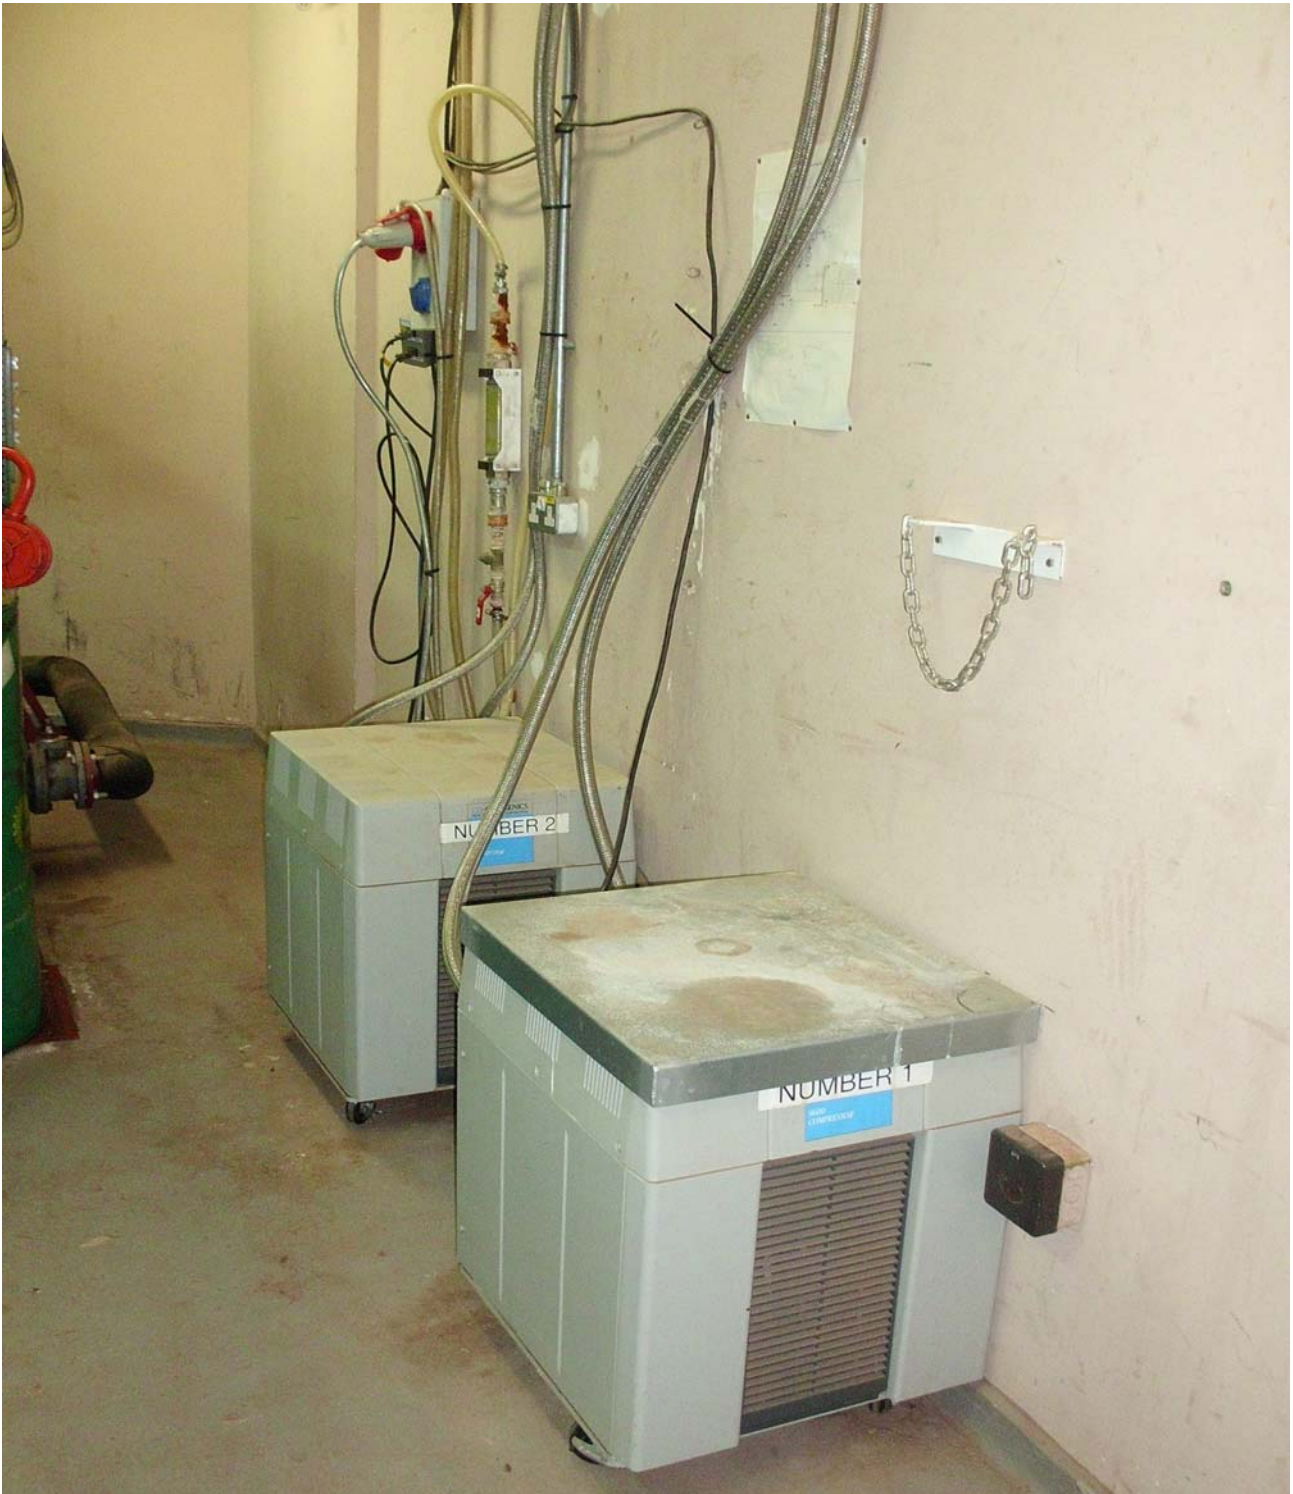
Solution : The relays of the cold head motor control board have been installed outside the cold head on a DIN rail. The original relays K1 and K3 were burned and affected the card where they were soldered.
