WILLIAM HERSCHEL TELESCOPE

A REPORT ON WORK CARRIED OUT ON THE WHT PRIME FOCUS INSTRUMENT PLATFORM

A NEW CALIBRATION PROCEDURE FOR THE PFIP AUTOGUIDER X-Y PROBE

Date : March/April 2002

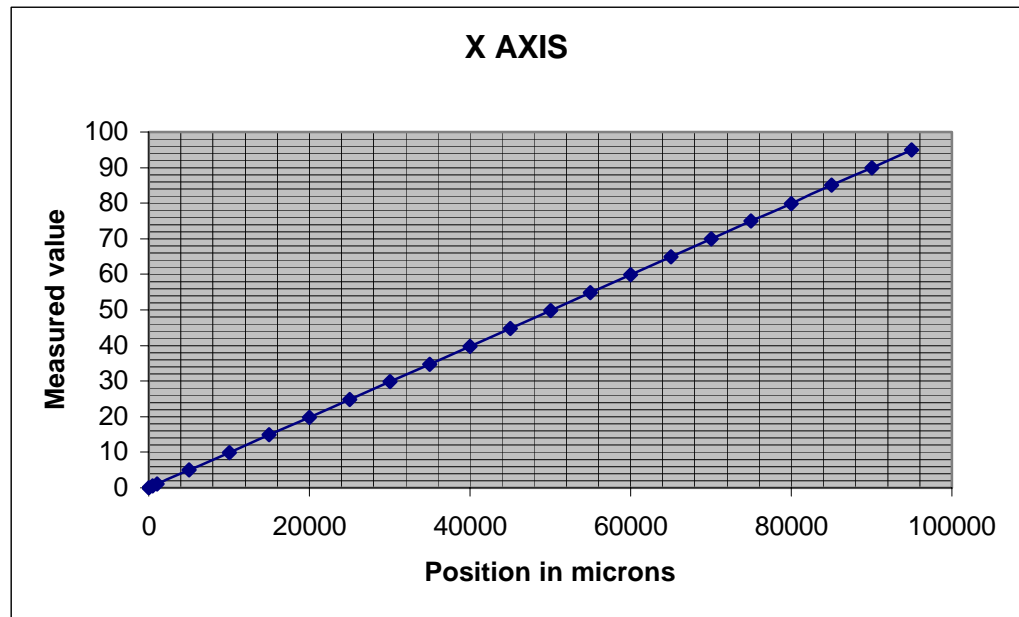
X AXIS CALIBRATION

These values show a small drop-off around 35,000 microns, but improving again towards the maximum travel of the encoder. However, in practice this should not present a problem. The error at 35,000 being ~ 240 microns. * Why this is the case is unknown. However, multiple readings taken between 0 – 110,000 microns always averaged out around +/- 30 microns.

n.b. This encoder was later changed on site when it failed completely so the data above is no longer valid. I have kept the data above purely for historical reasons. See page 15 for the new encoder data.

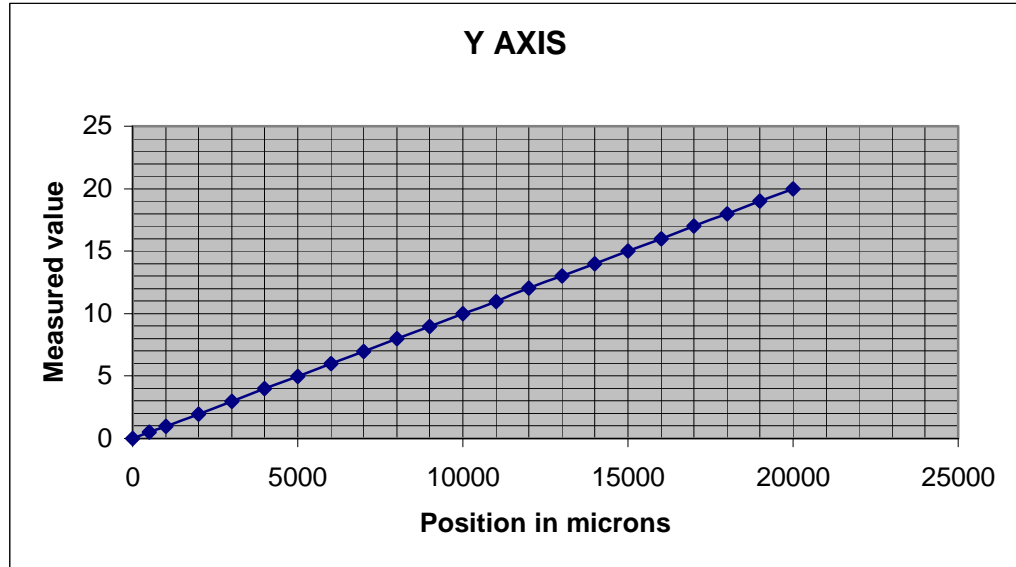
Y AXIS CALIBRATION

These values are very close to the demanded positions. The measured values returned were within +/- 20 microns.

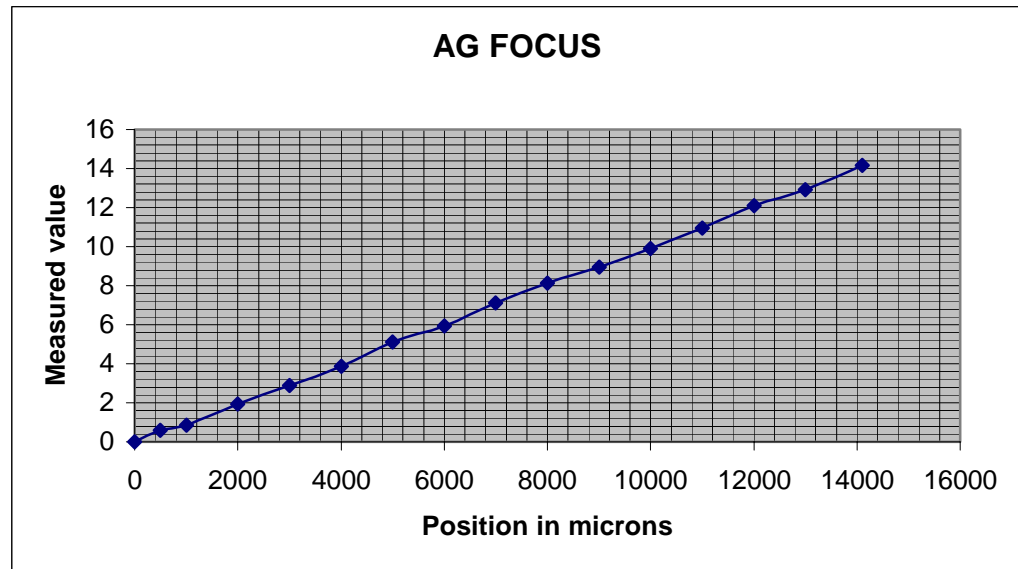
AG FOCUS CALIBRATION

These values are not as close as I would have liked, but they all average within ± 150 microns.

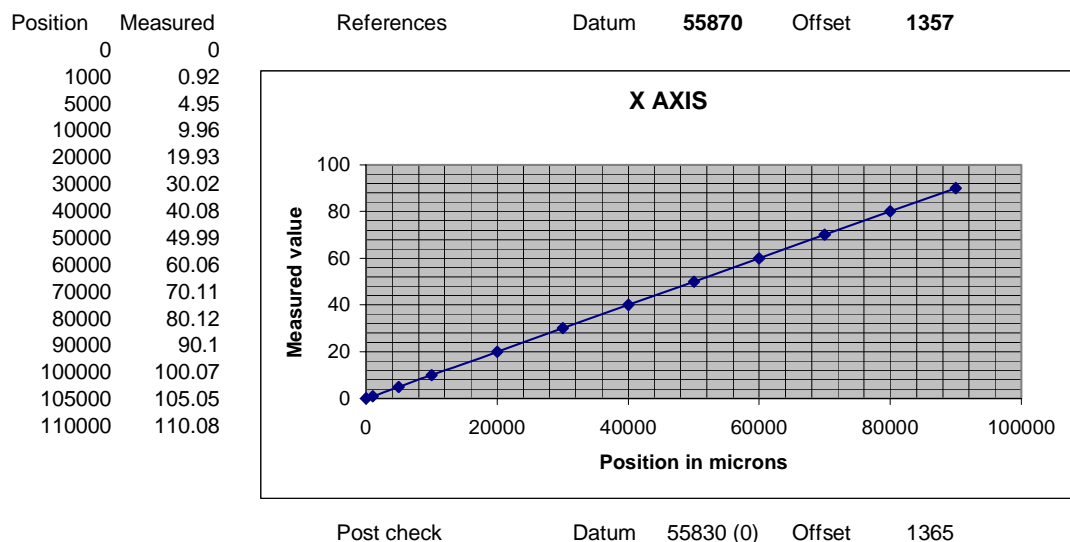
X AXIS CALIBRATION (after encoder replacement)

However, on measuring the distance covered by the X slide, I found this had changed considerably, with the **mechanism moving 108,000 microns when the maximum value of 110,000 microns was demanded**. I also found that the ZERO offset had changed to a very high value and it was impossible to adjust this below 32,000 units...

I changed the APX EM-2 module, but this made no difference. I came to the conclusion that the Penny Giles encoder had failed and needed to be replaced. Worked started on removing this immediately and when released from it's mounts, was found to be far from smooth and 'lumpy' in operation. Once the replacement encoder was cabled in, I checked that I could adjust the EM-2 module to the required ZERO value and that the encoder read correctly over its range. All was working correctly again.

After re-fitting the new encoder, I then had to go through the entire procedure of adjusting the ZERO and GAIN presets and re-aligning the datum. The results of the encoder change are shown in the graph below.
