Reflectivity Report for INT Primary Mirror before and after soap & water washing, 5 October 2017

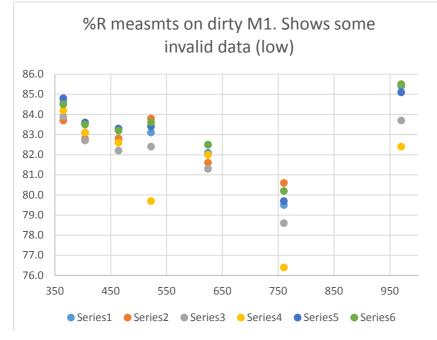
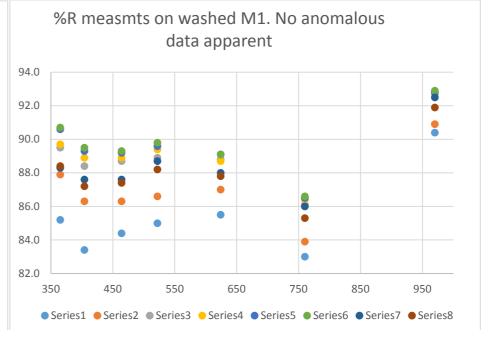
Anomalously low values (visible in graph) highlighted in red, judged to be caused by this movement, are omitted from statistics.

Maxima and minima highlighted in green & orange respectively, are valid and included.

Discussion: the location of the lowest %R measurement after washing is just above the central hole. The second lowest is some distance away.

All other values were much higher, but a check of the reference mirror shows the instrument has not drifted. Omit this unrepresentative data.

Conclusion: the cleaning was very successful, improving on the CO2 cleaning in July by 0.5 to 1% Reflectivity and reducing scattering by up to 2%.
